## **Mt Claire Park (in Mt Baker)**

Mt Claire Ave and Park Drive

### Mount Claire Viewpoint (at Mt. Baker)

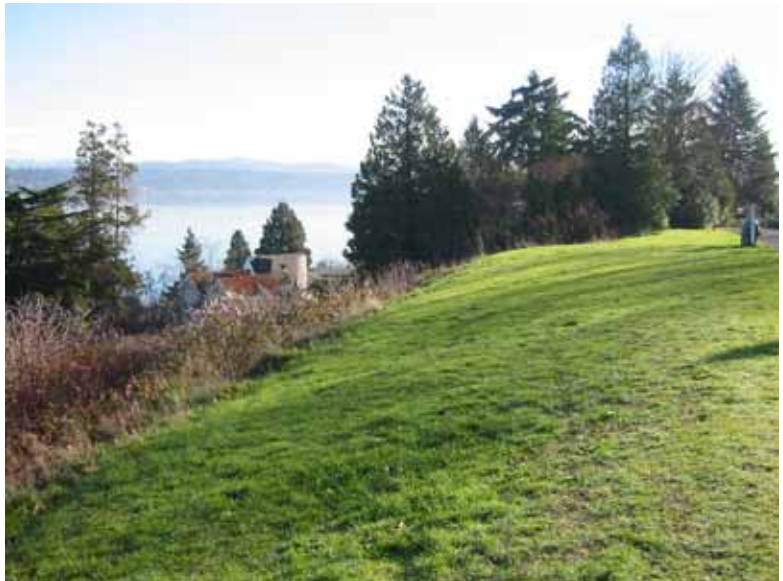
The hillside has recently been cleared. Himalayan blackberries inhabit the steep 75% slope. The crest shows signs of erosion and instability. Maintenance access exists both above and below the slope.

Crest of slope, transition  
zone

1. Invasive weed removal at the crest of the slope
2. Erosion control matting may be necessary
3. Plant low hedges along Transition Zone 2
4. Mulch at crest of slope and new plantings
5. Irrigate to establish new plants

- Phase 1 - Remove invasives at top of slope
- Phase 2 - Cover slopes with erosion control mat where needed  
Plant Zone 2 transition hedge at top of slope  
Irrigate new plantings

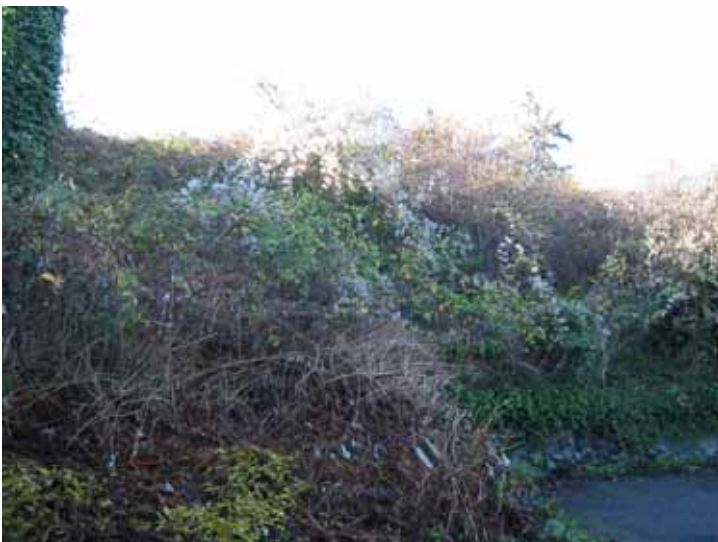
Overgrown vegetation from  
toe of slope
